Exponent[®]

Li-Ion Cell Cap Corrosion Monitoring

Background

Scope of Investigation

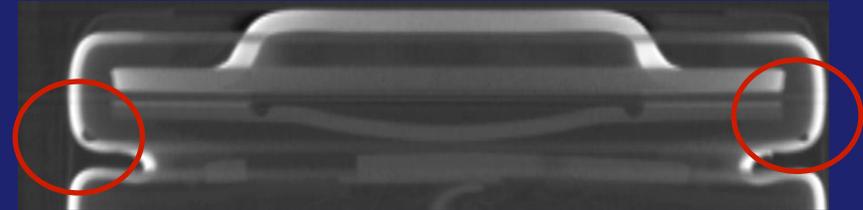
Location of Corrosion

- Corrosion pits tend to be coplanar around cell circumference
- Consistent with tool contact to the interior of the can during neck formation

- **The Ni plating was damaged, exposing the substrate**
 - Marks surrounding pits are consistent with tool contact
 - Multiple operations during cell assembly could potentially require tool contact with top interior of cell case
- The area between the seal and the cap surface is a natural crevice, trapping moisture or other fluids
 - Electrolyte would be expected to be present in this area
- **Galvanic corrosion cell develops between nickel and iron resulting in iron dissolution**
- **Rate of corrosion will depend on multiple factors and must be determined empirically**

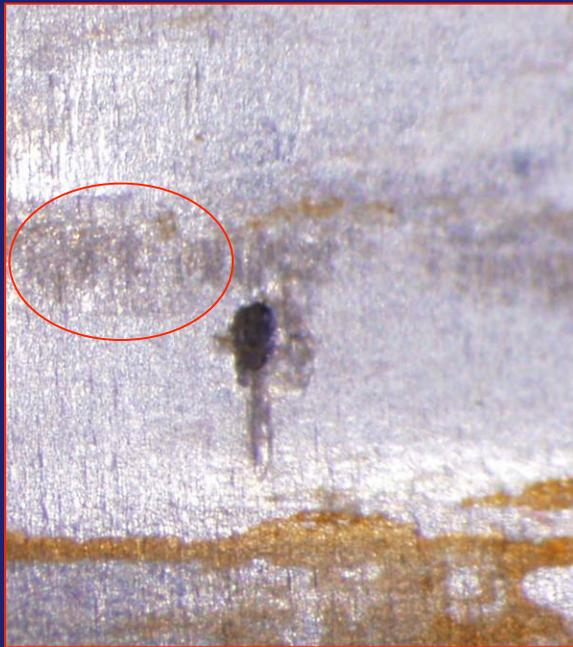
After Cleaning

Some surface roughness, likely the precursors to pitting, was also seen on the interior surface (circled).

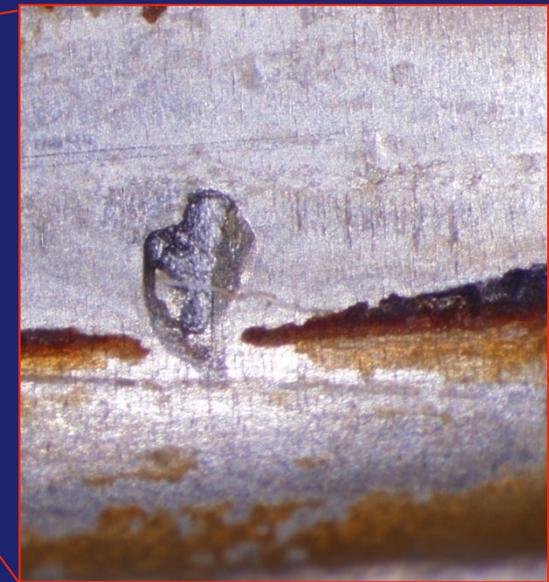
- After the electrolyte and corrosion product were removed, pits of varying sizes and depths could be seen
- Most pits were located approximately midway between the cap top and the crimp, though some were located closer to the crimp area (arrow)

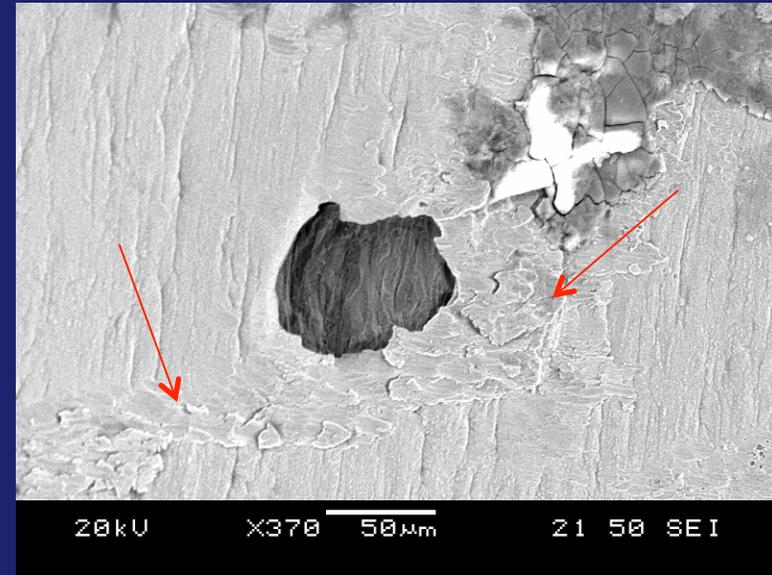
Other Surface Features

- Rub or scrape marks (arrows) were seen adjacent to several, but not all, pits
 - This may indicate the coating was broken or damaged, exposing the substrate material
